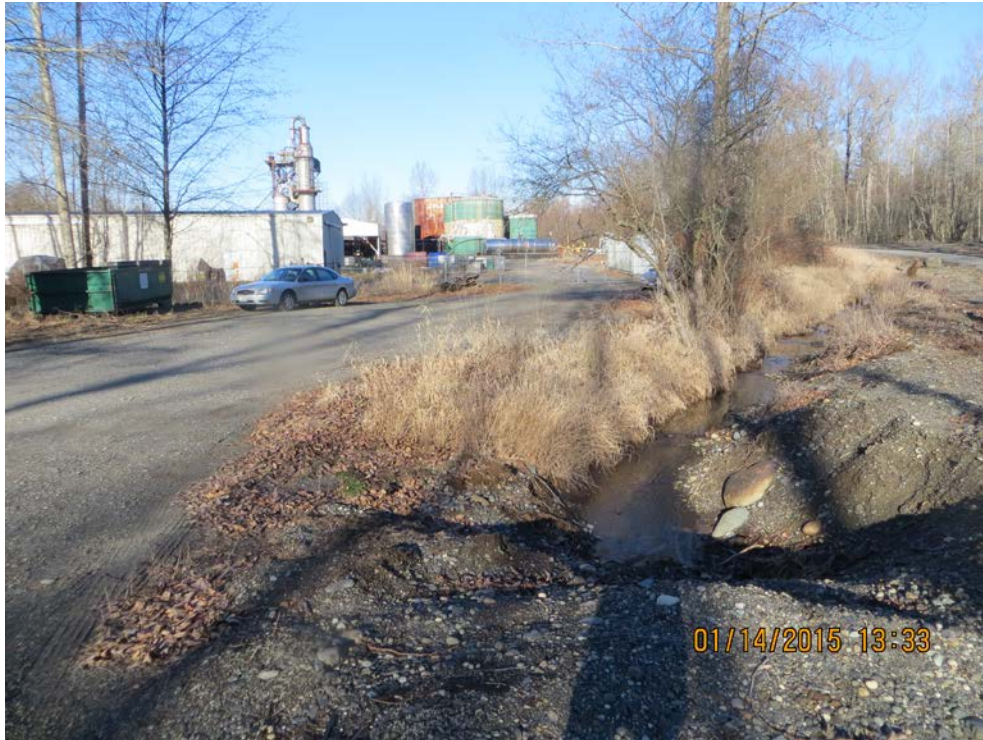
Photo 1 – Drainage way adjacent to rail spur which runs along Treoil's eastern property boundary of Treoil. This drainage way enters a culvert beneath the driveway and continues west along the southern property boundary.

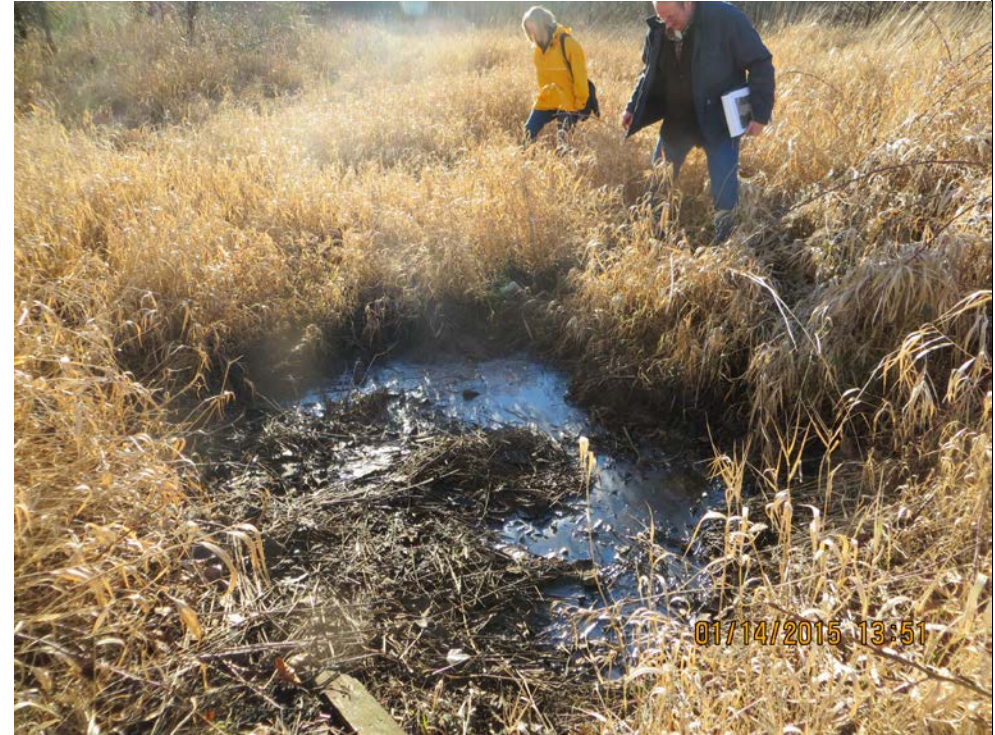
Photo 2 – Low spot in field just outside SW corner of fencing. The ground is stained black. Runoff associated with industrial areas inside the fencing is collected here.

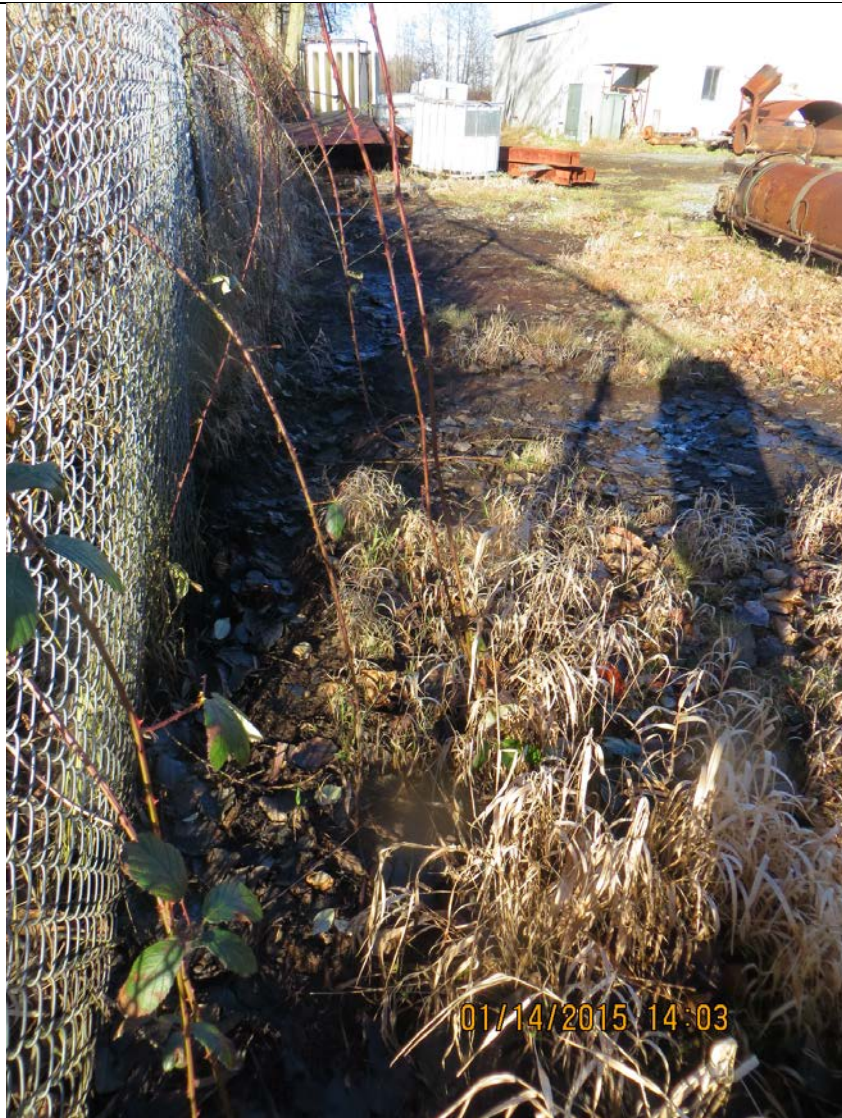
Photo 3 – Pathway of runoff from industrial areas to low spot just outside the fencing (see Photo 2).

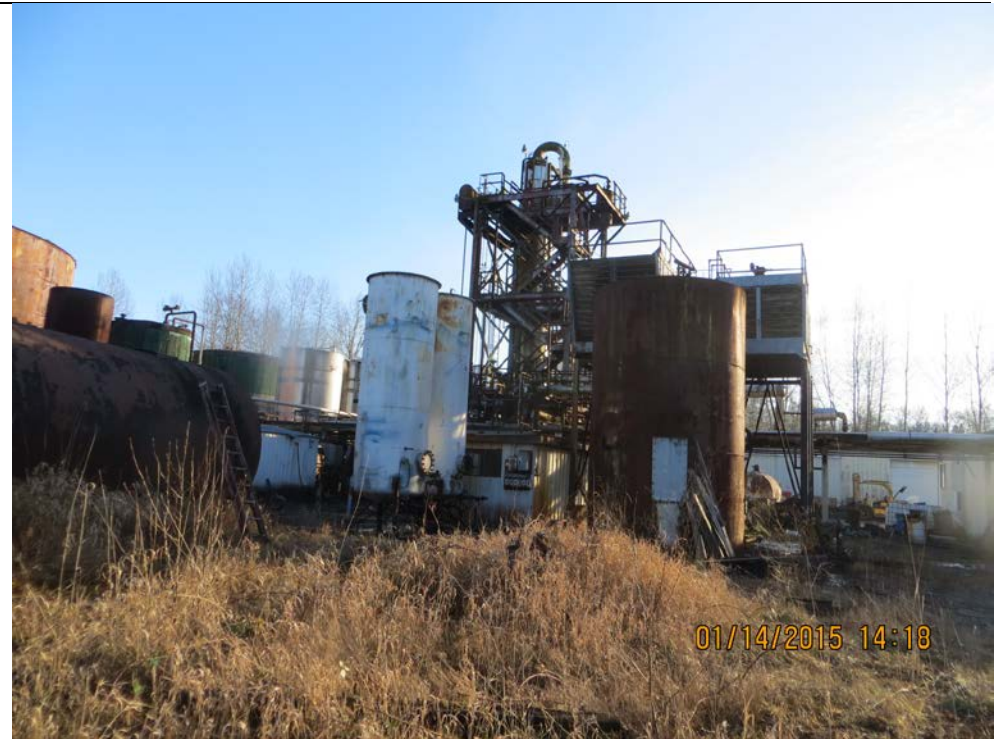
Photo 4 – “Industrial area”

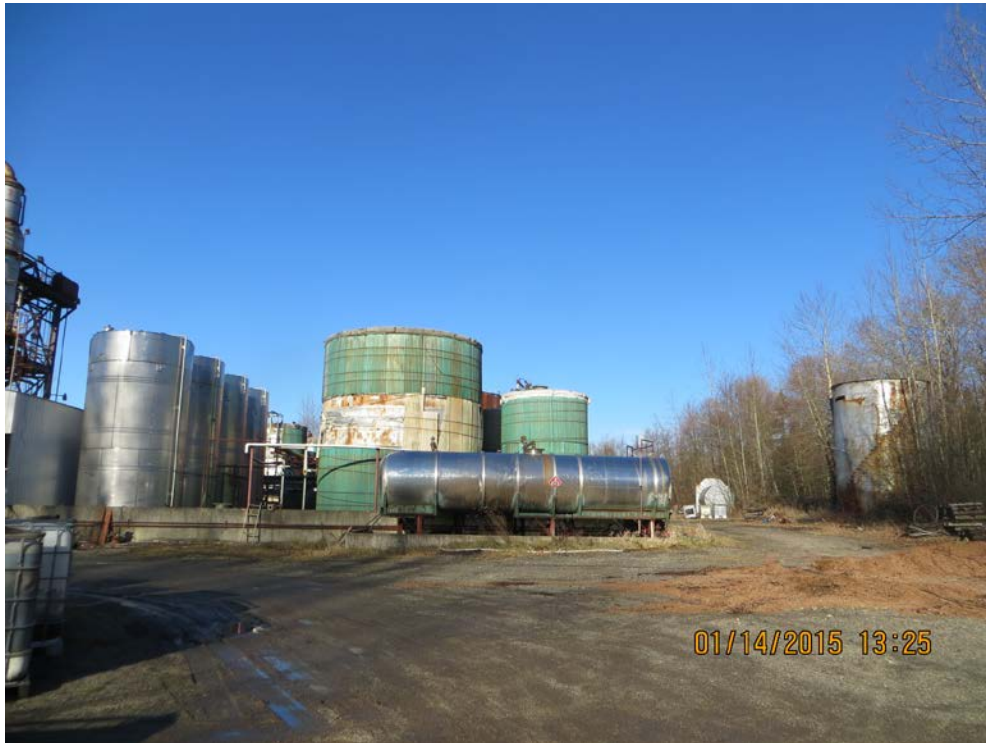
Photo 5 – “Industrial area”.

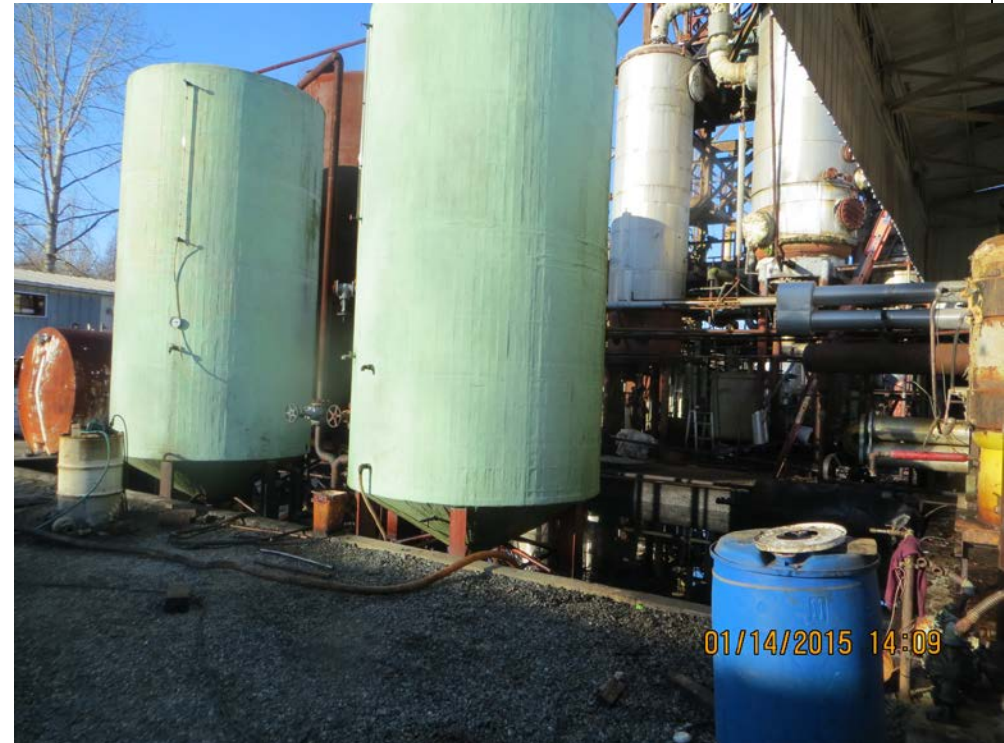
Photo 6 – Aboveground storage tanks in secondary containment.

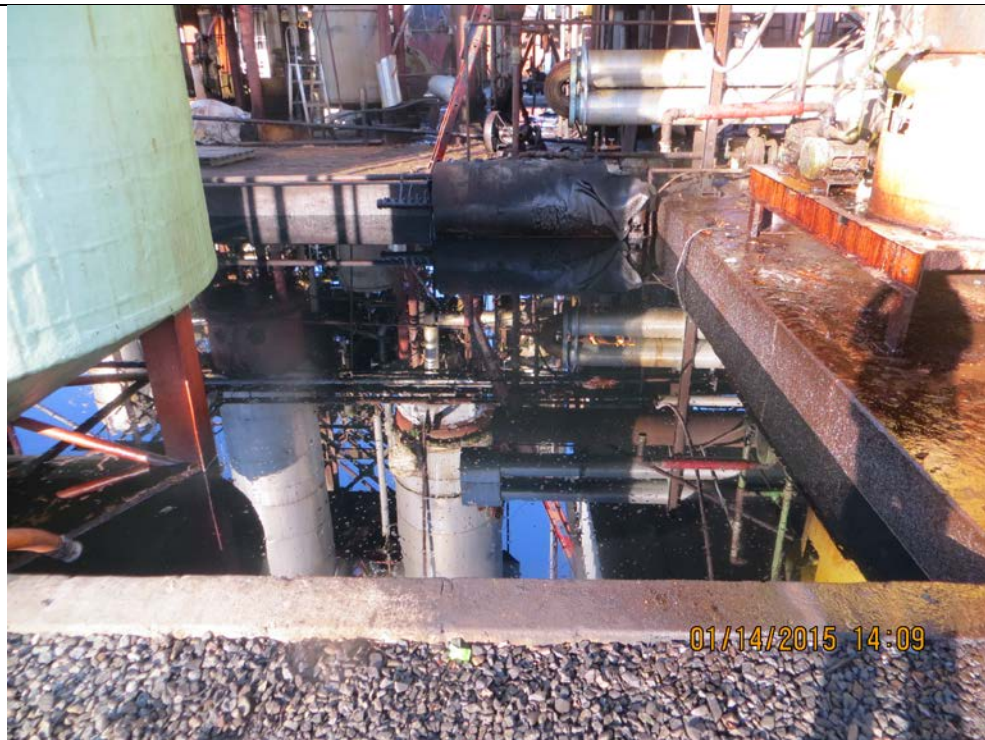
Photo 7 – Secondary containment holding stormwater. Due to the reflective nature of the water within the containment we were unable to see the bottom of the structure.

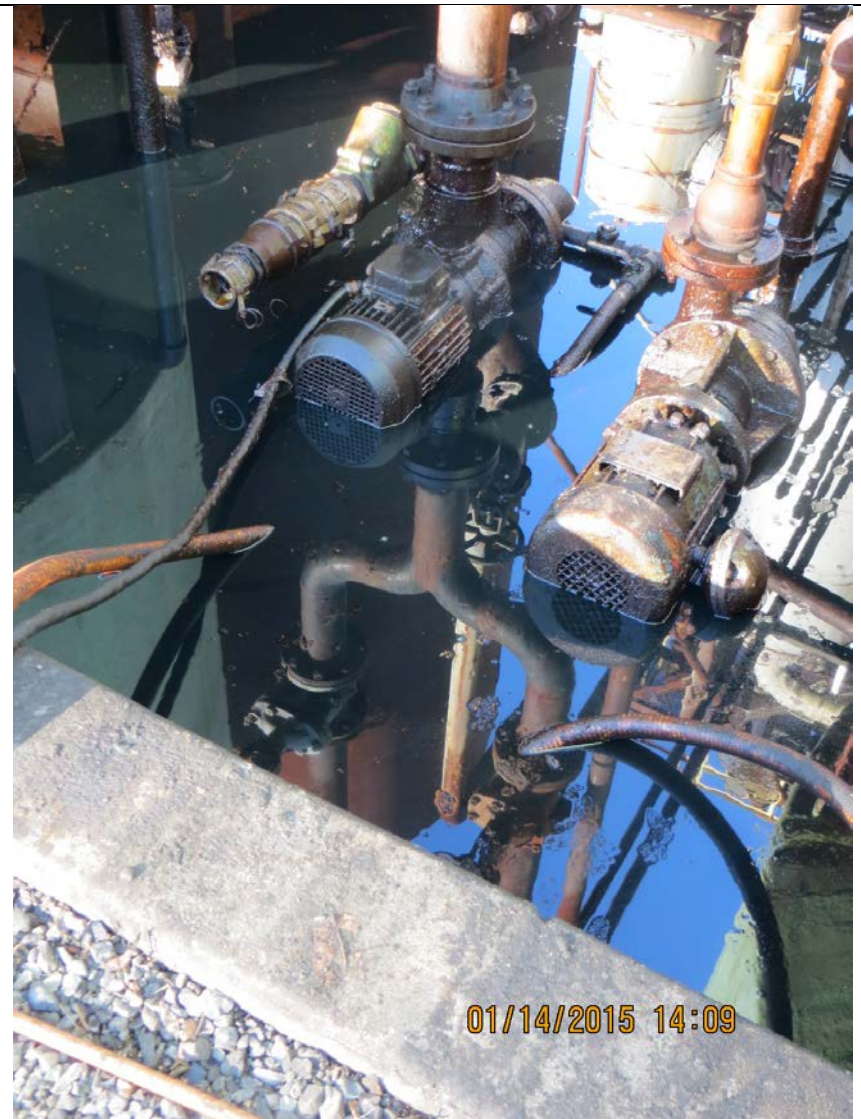
Photo 8 – Stormwater contained in secondary containment.

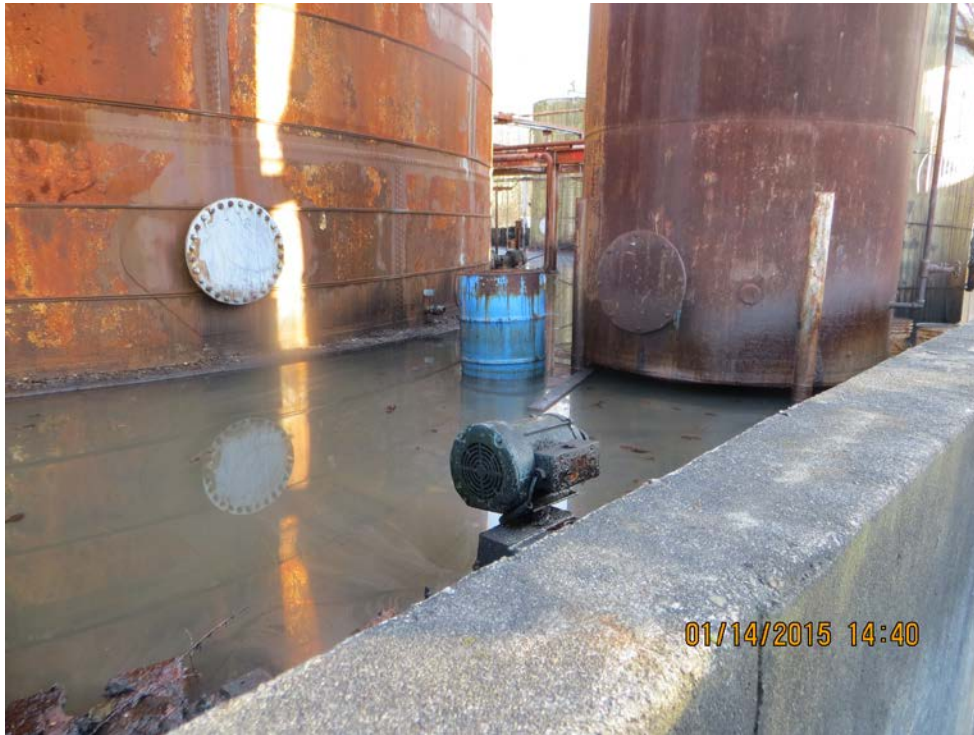
Photo 9 – Stormwater contained by secondary containment.

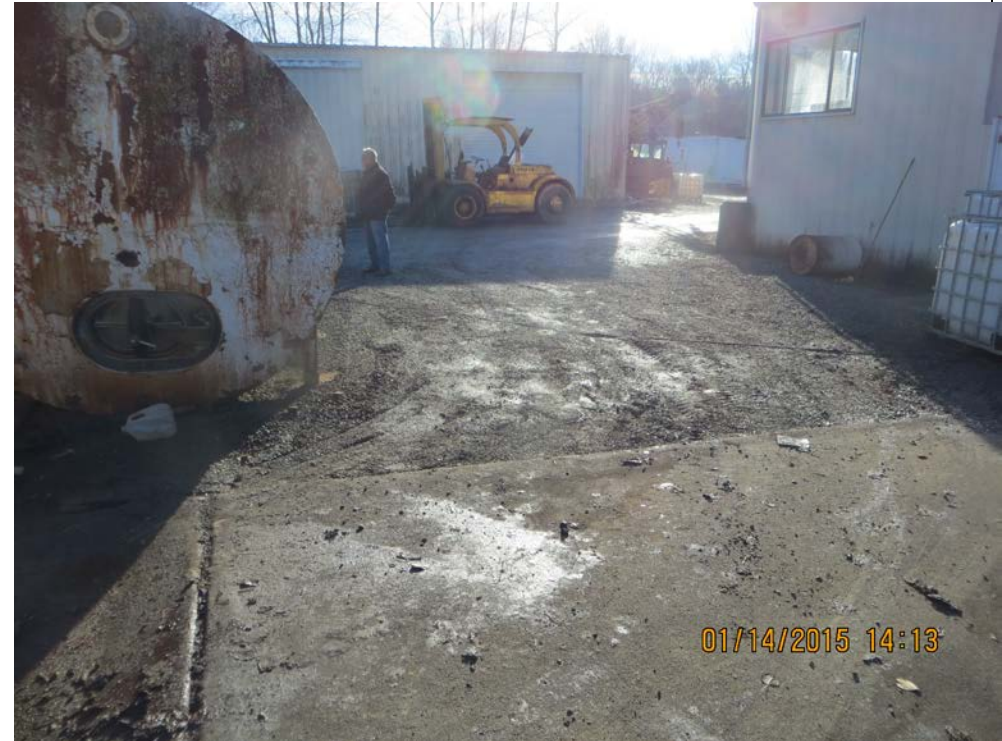
Photo 10 – Mr. Gill stated stormwater was recently pumped from within the secondary containment, skimmed for product and then discharged to the bare ground. The stormwater was not tested to determine if it meets state water quality standards.

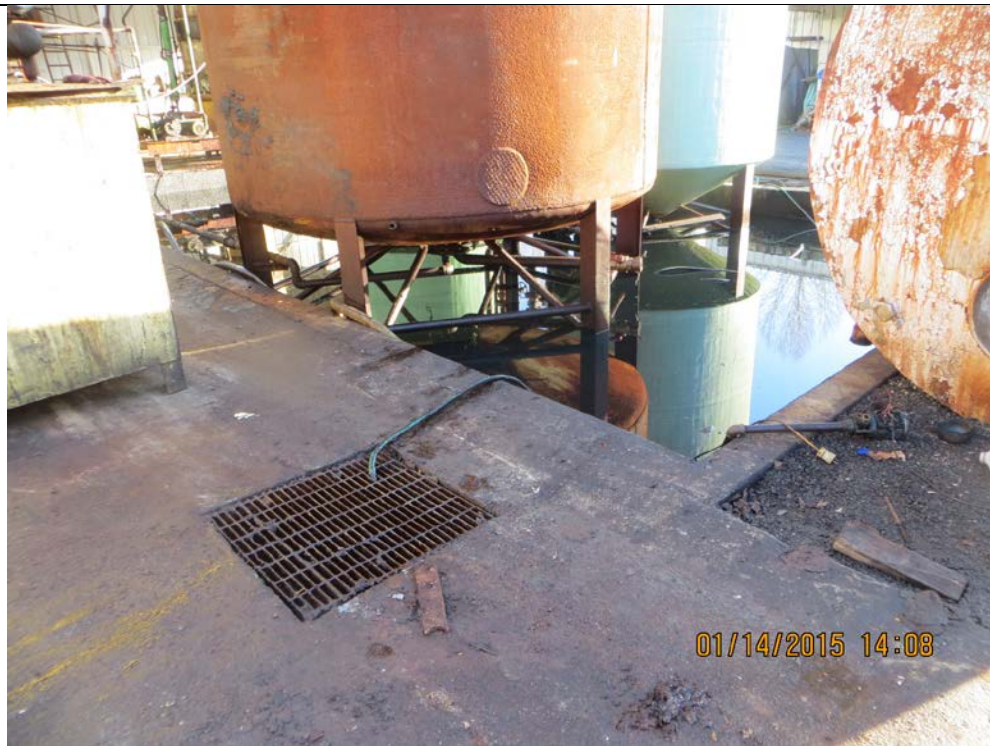
Photo 11 – Hose from pump in secondary containment to sump in “refinery area”. Mr. Gill does not know if the sump has an outlet. Debris present inside the sump prevents a visual inspection for an outlet.

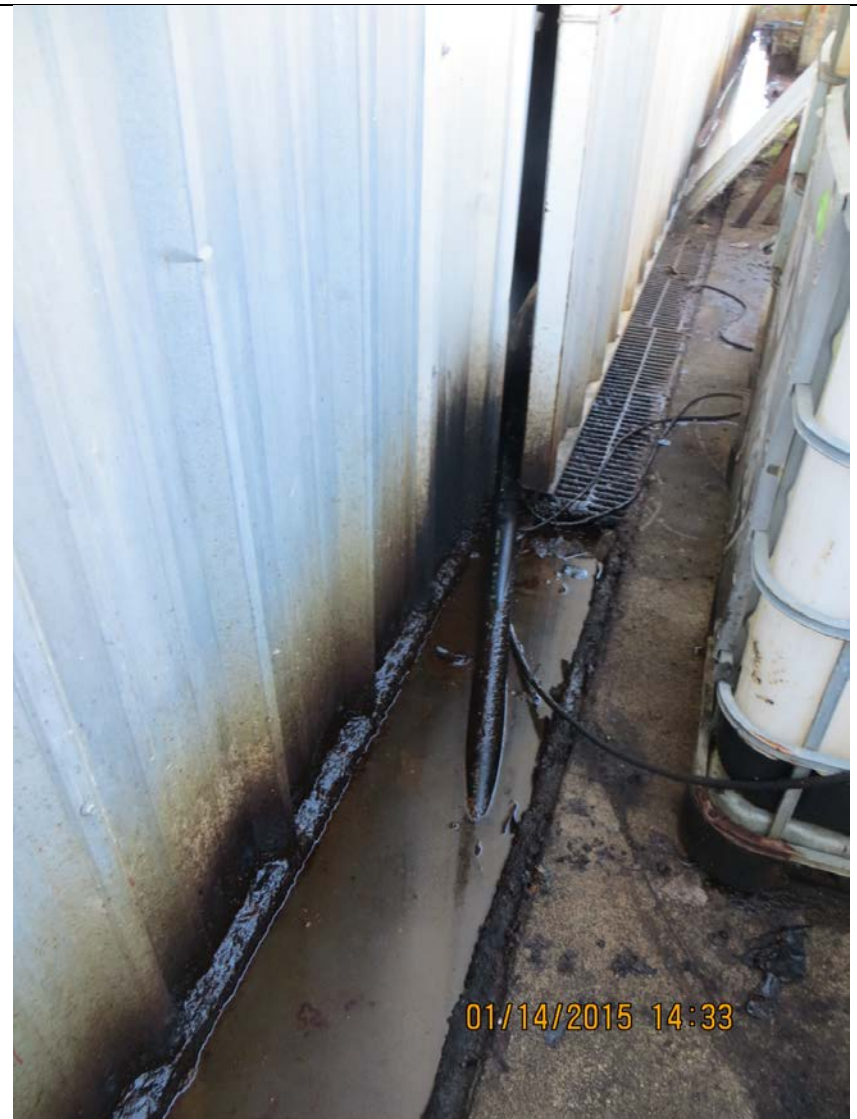
Photo 12 – Drainage associated with one of the permanent buildings within the industrial area. The discharge location for this drain is unknown.

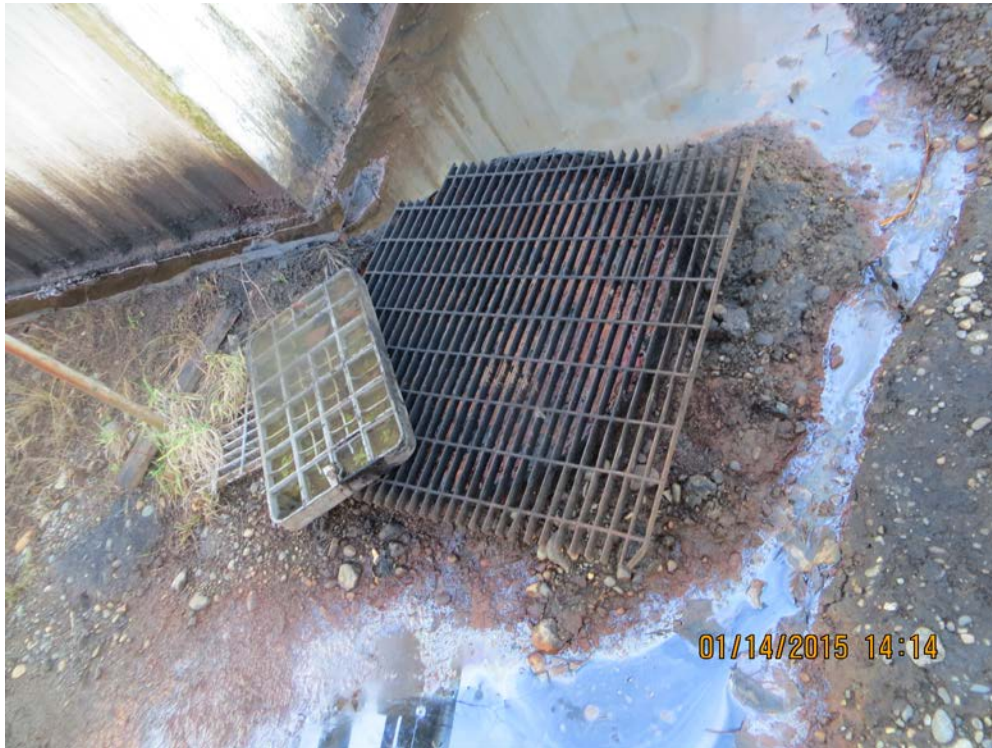
Photo 13 - Sump outside one of the two permanent buildings. Debris inside the sump prevents a visual inspection for an outlet. The discharge location is unknown.

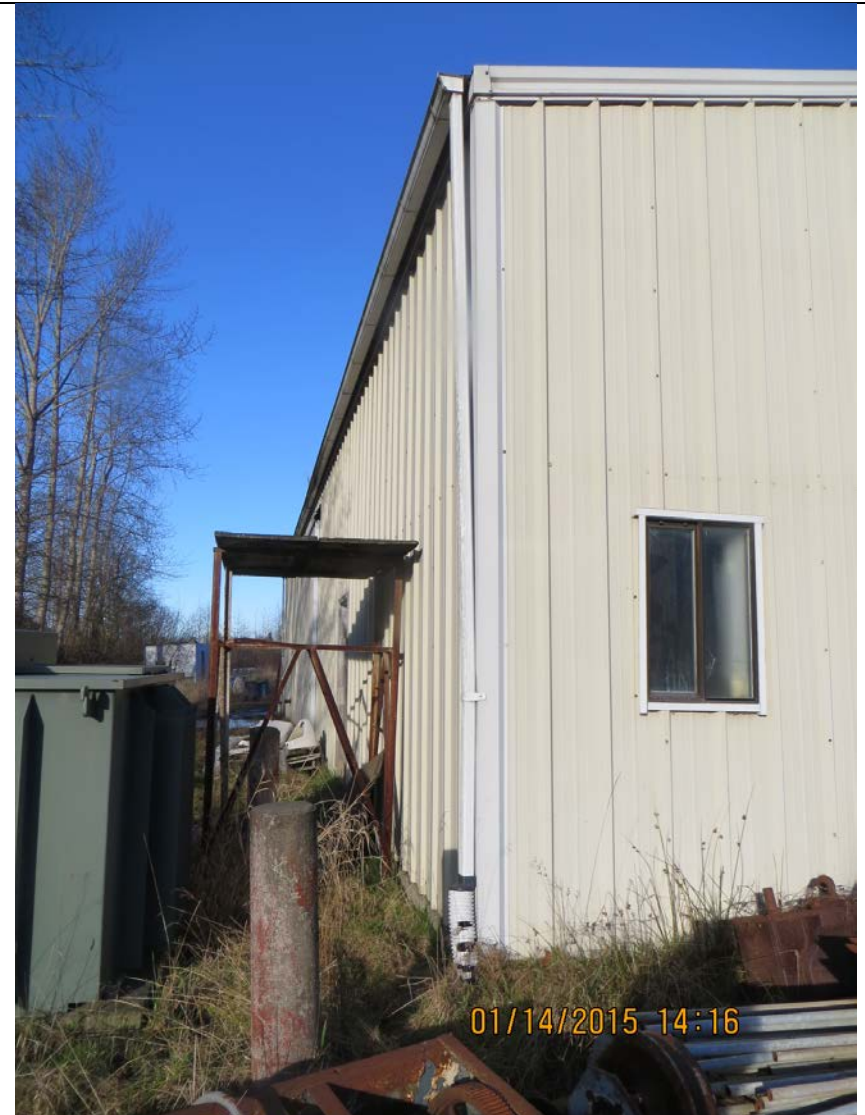
Photo 14 – Roof drainage on permanent buildings. Discharge locations are unknown.

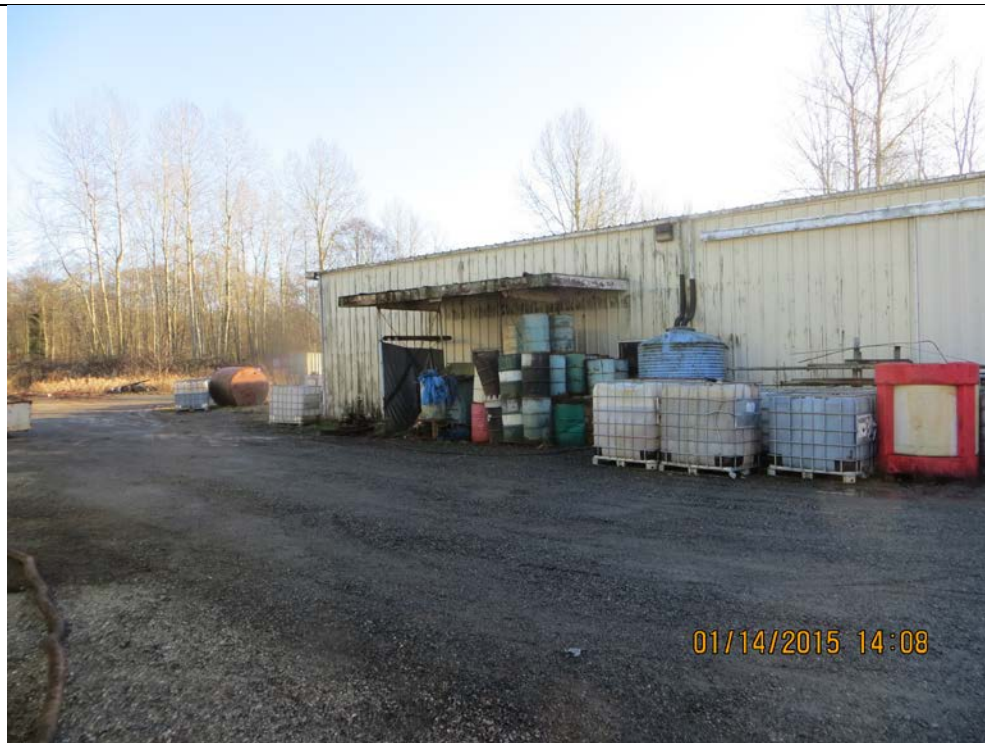
Photo 15 – Liquid storage outside one of the permanent buildings. No secondary containment for the liquids. Many of the containers are unlabeled.

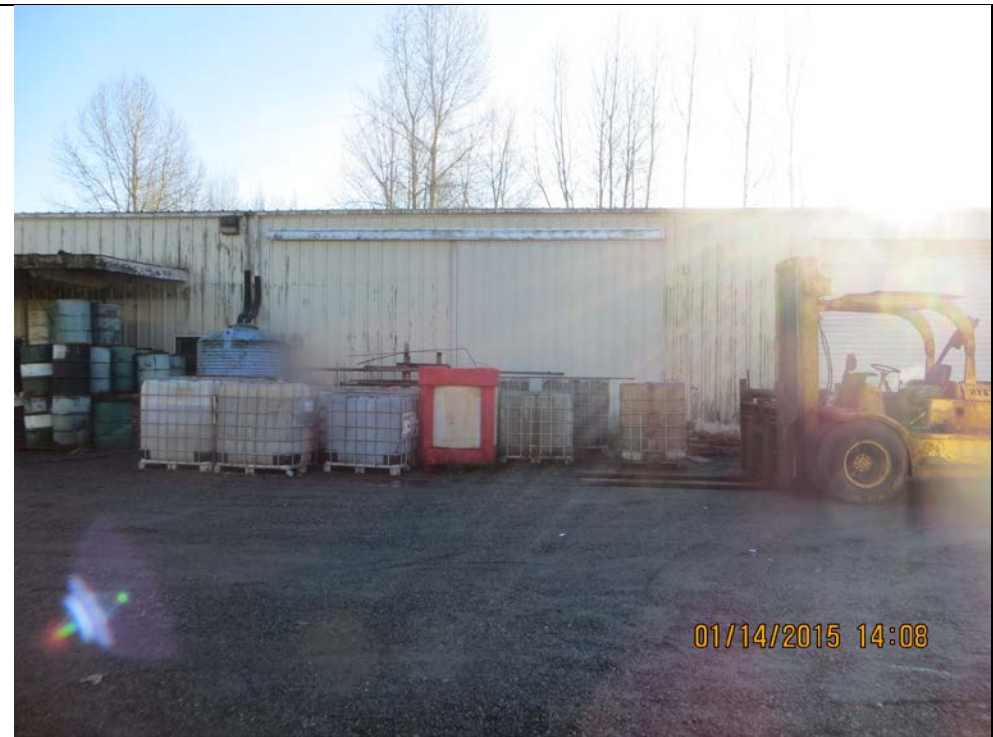
Photo 16 - Fluid storage outside one of the permanent buildings. No secondary containment for the liquids. Many of the containers are unlabeled.

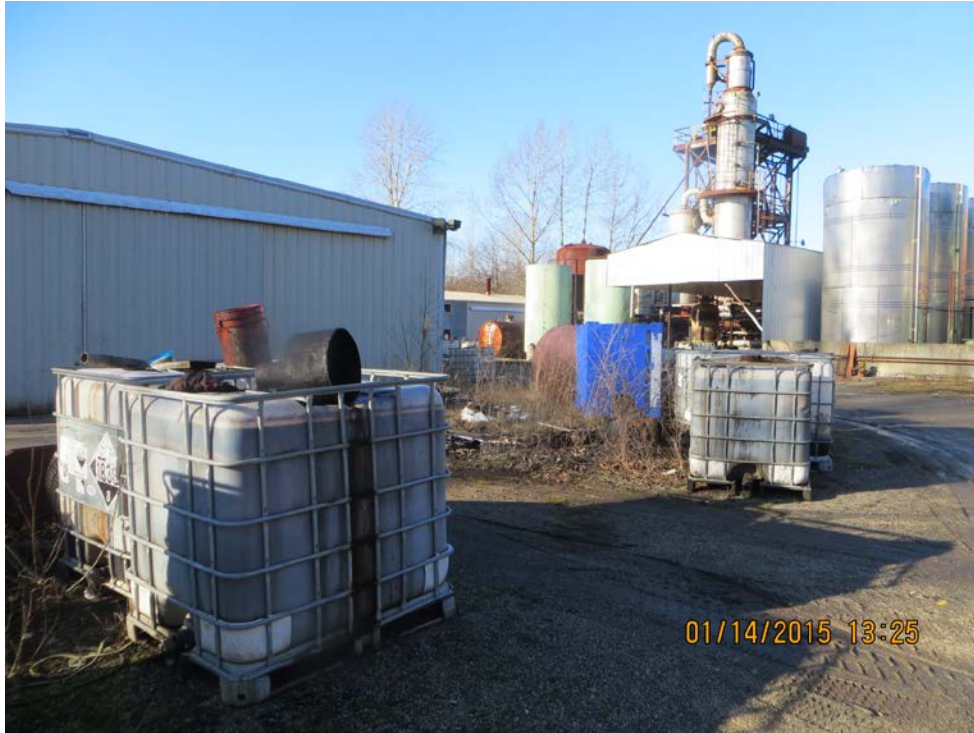
Photo 17 – Liquid storage without secondary containment.

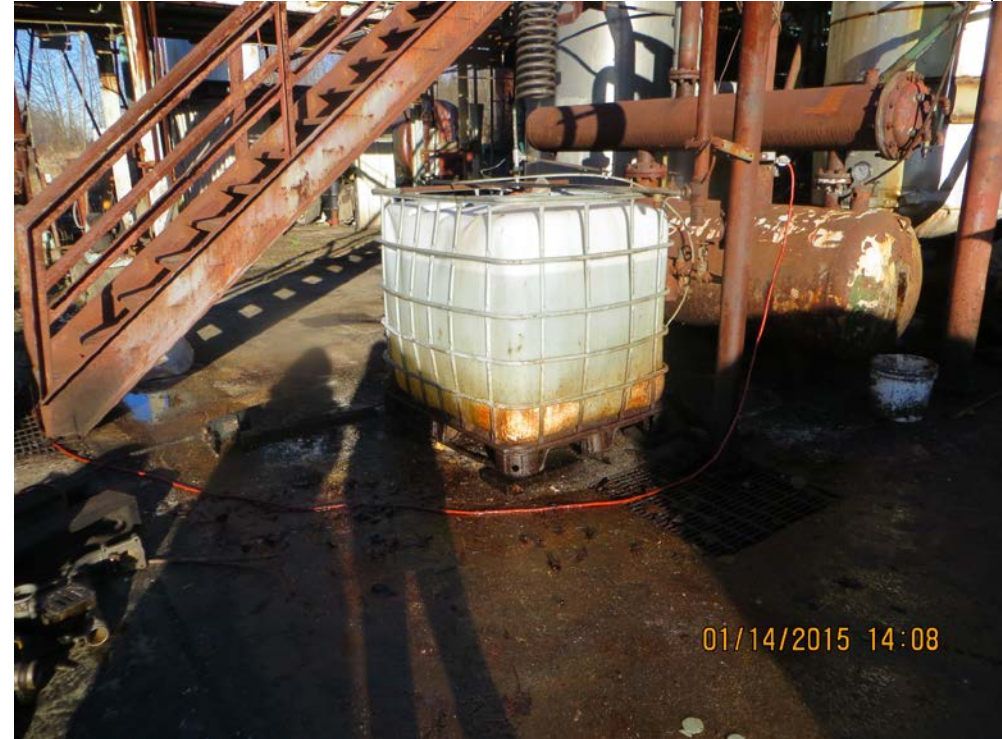
Photo 18 – Liquid storage without secondary containment.

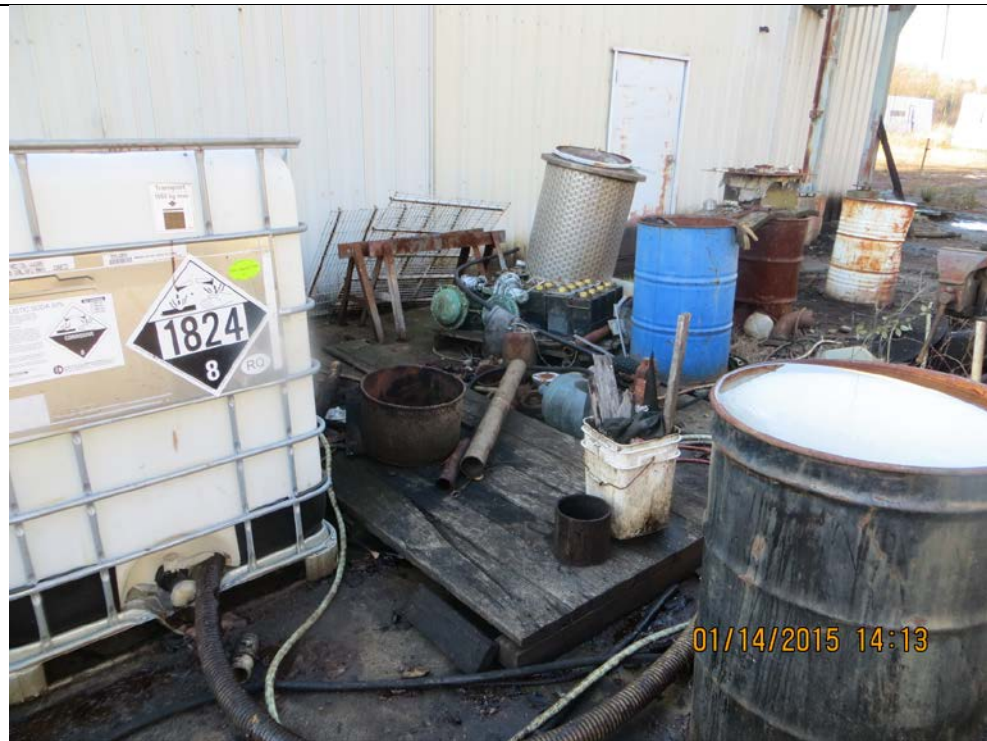
Photo 19 – Miscellaneous storage (including liquids without secondary containment).
